Copper Cabling
Troubleshooting Handbook

#### Introduction

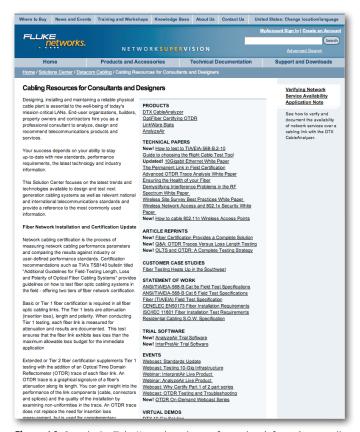
Figure 16: Consult the Fluke Networks web page for product information as well as updates in standards or white papers on best practices. Go to www.flukenetworks.com/design
